STRESS CORROSION CRACKING IN
ALMAR 362 MAR-AGING STAINLESS STEEL

A THESIS

In Partial Fulfillment
of the Requirements for the Degree
Master of Science in Metallurgy

Georgia Institute of Technology

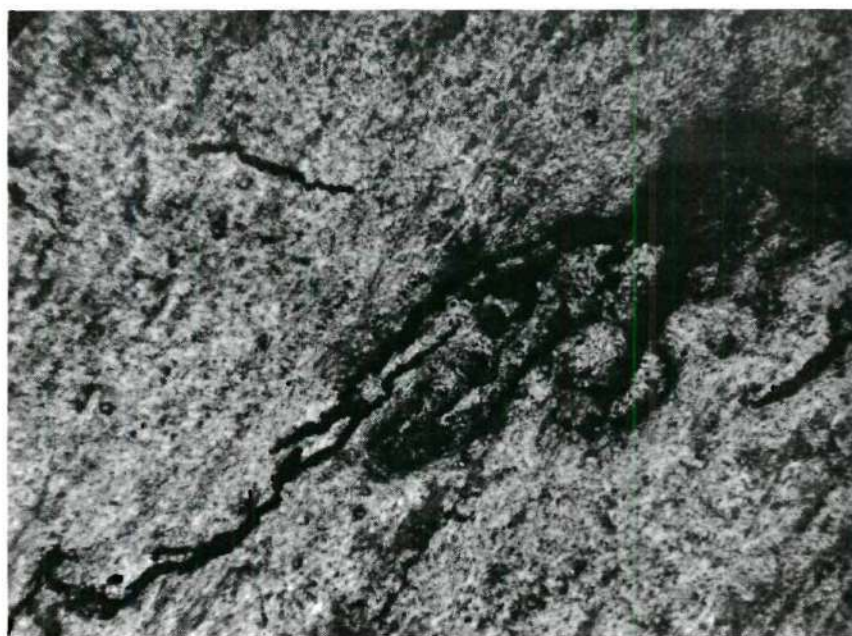
Figure 22. Typical Crack in Almar 362. Specimen Made Anodic in a 50% HCl + 1% SeO₂ Solution. (a Unetched, b Etched, Magnification 400X).

Fracture faces of all specimens were examined optically. A photomicrograph of the mode of fracture is shown in Figures 20, 21, and 22. It was noted that material had apparently been removed from the cracks by the corroding solution as evidenced by the rounded, wide nature of the crack. This dissolution effect was not caused by the

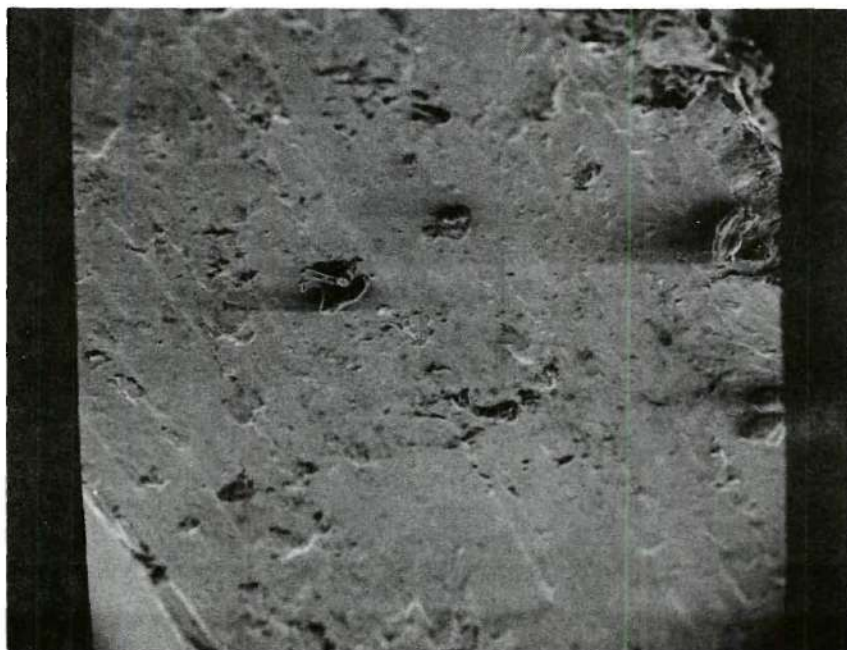
Figure 24. Scanning Electron Micrograph. Specimen No. 1 Cracked in a 10% NaCl + 5% HA_c Solution (Magnification 260X).

Figure 23 shows a fracture surface of a typical tensile tested specimen; here the ductile nature of the fracture is pronounced. Figure 24 shows a fracture in a 10% NaCl + 5% H_2O_2 solution without any impressed current. The fracture has the appearance of quasi-cleavage. In Figure 25, cathodically cracked specimen, the cleavage appearance of the fracture is clearly observed across the specimen starting at the top right hand corner close to the machined notch; however, the final fracture area on the left side is of a ductile nature. From Figures 25 and 26, both cathodically cracked specimens, the fracture seems to be transgranular cleavage although some areas may show indication of intergranular failure. Figure 27, anodically cracked specimen, also shows some cleavage appearance, here the corrosion attack is more pronounced because anodic polarization caused attack of the crack surface; this fracture looks more transgranular.

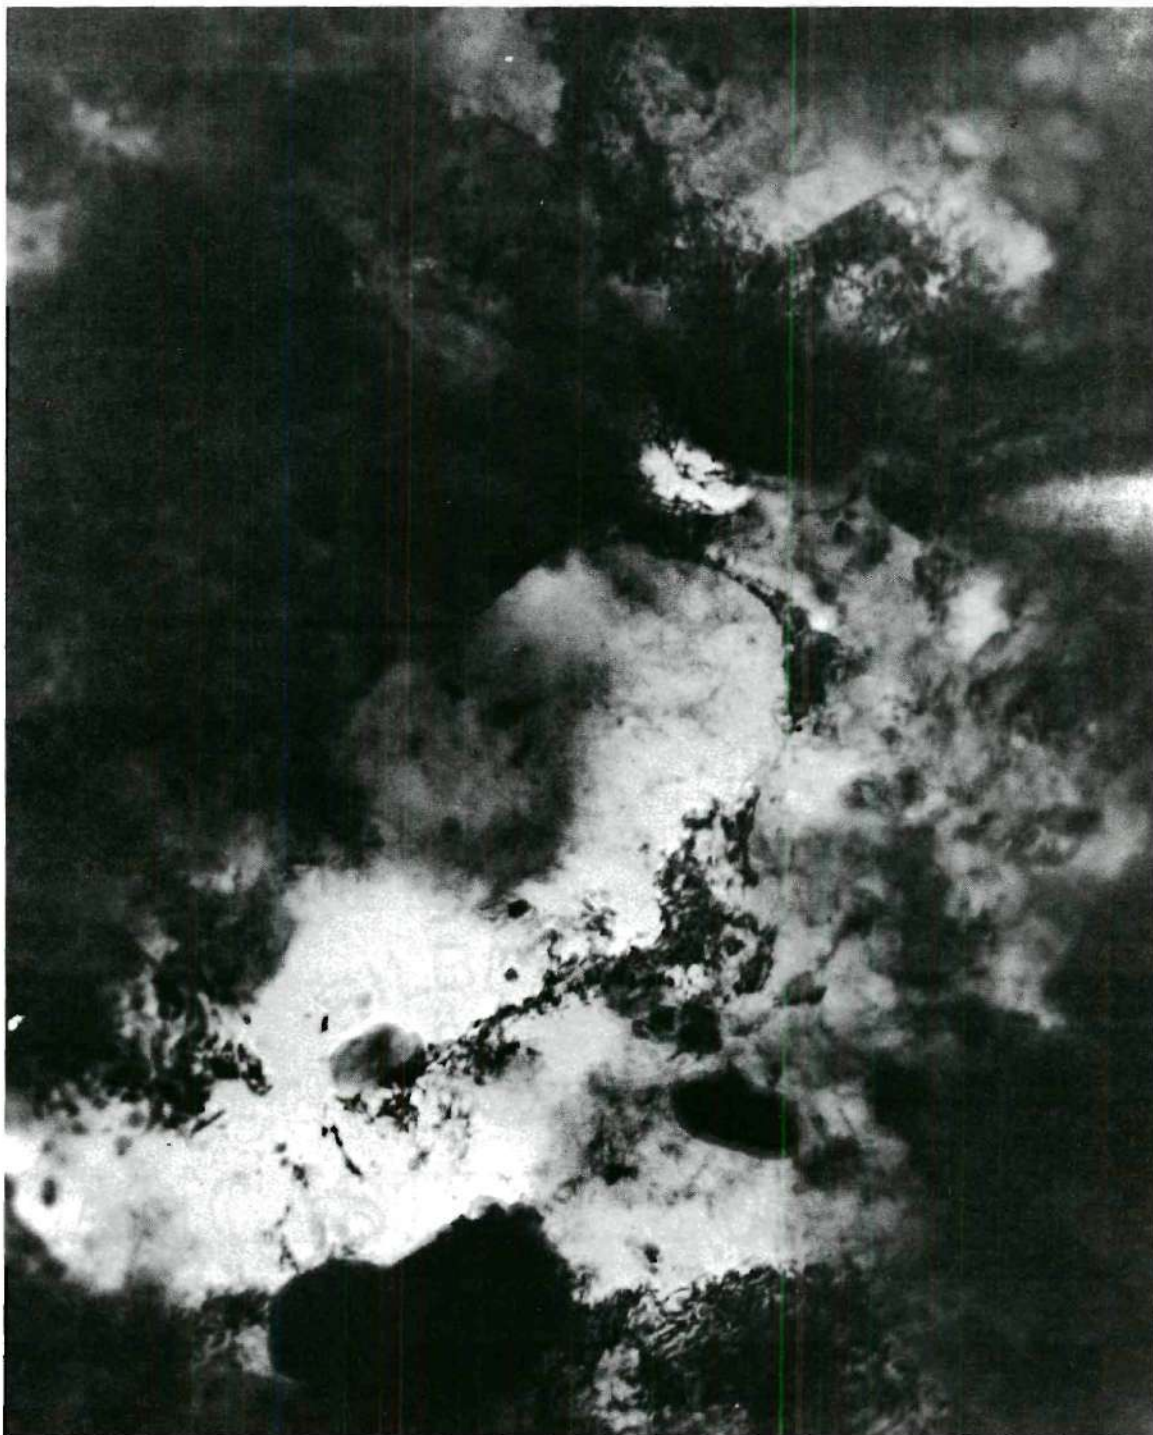
Figure 33. A Transmission Electron Micrograph of Almar 362. Specimen No. 2 Made Cathodic in a 50% HCl + 1% SeO₂ Solution.

to identify dislocations positively except when they lay almost in the plane of the foil. Many of the dot-like features in Figures 28 to 33 may be dislocation inclined to the plane of foil. Due to these difficulties, a crack formation theory based mainly on dislocation interactions would be impossible.
